Manhole Inspection Summary

Manhole # S41AA_038MH

Insp Date: **8/6/08 10:07 AM**

Location Address: **738 wharton ct**

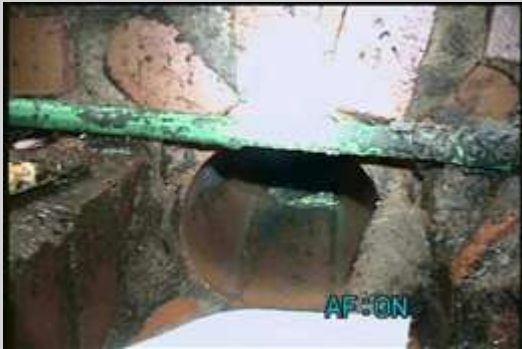
12 O'Clock Outflow

8 in. Circular Gravity Sewer
Pipe Out @ 12 O'Clock

Pipe Material: **Clay** ☐ Pipe Lined

Invert Depth: 7.92 (ft.) Flow Characteristics: **Slow**

Deposits: ☒ None ☐ Mud ☐ Sludge ☐ Debris ☐ Grease

Infiltration: **None** Pipe Seal Cond: **Unknown**

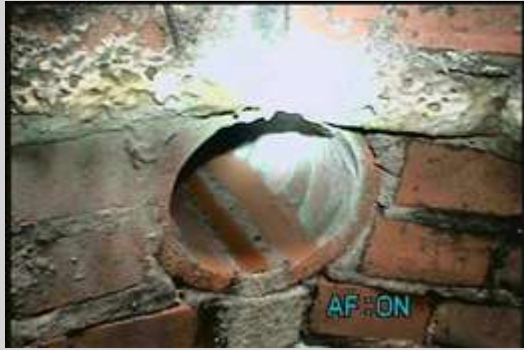
7 O'Clock Inflow

8 in. Circular Gravity Sewer
Pipe In @ 7 O'Clock

Pipe Material: **Clay** ☐ Pipe Lined

Infiltration: **None** Pipe Seal Cond: **Unknown**
